**CERAMIC MATRIX COMPOSITE CHARACTERIZATION UNDER A
COMBUSTION AND LOADING ENVIRONMENT**

THESIS

AFIT/GMS/ENY/09-M01

Degree of Master of Science (Materials Science)

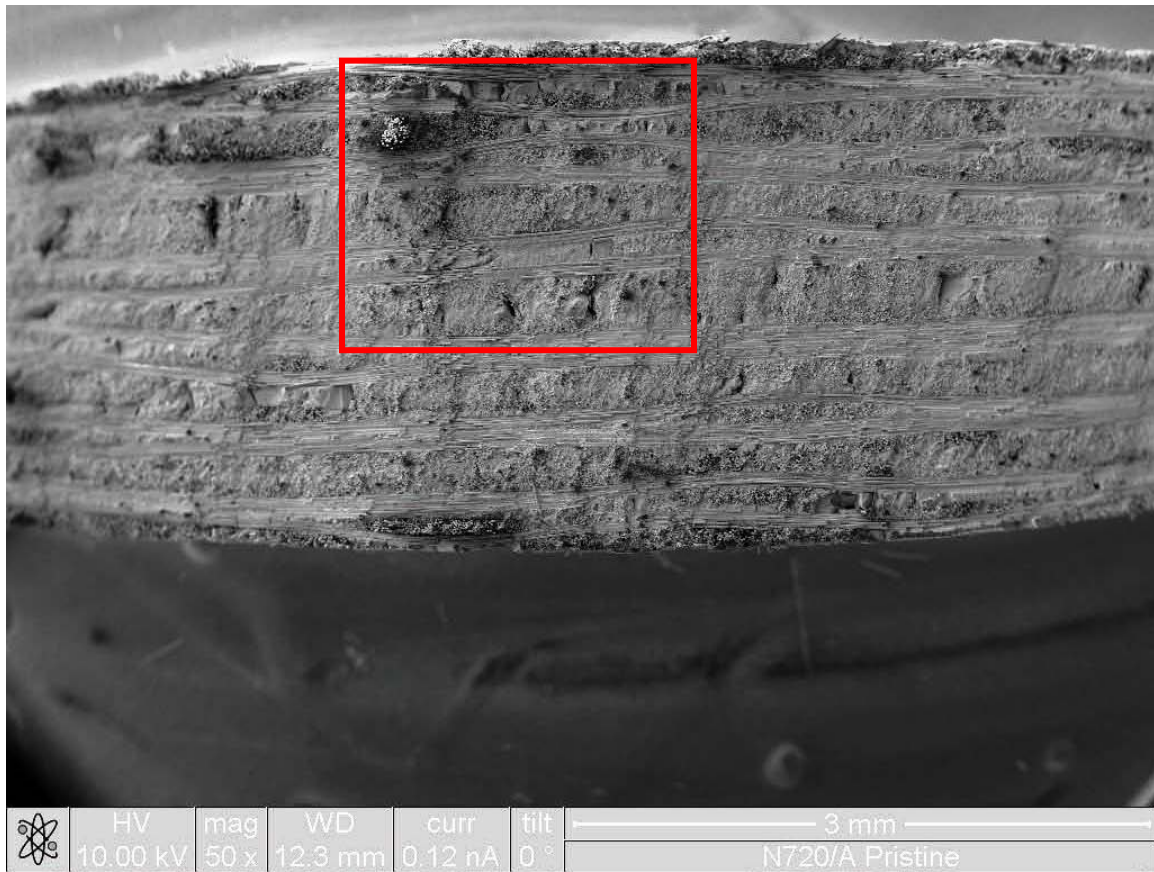
Figure 47. Pristine Specimen Overall Interior Structure

Figure 47 to Figure 49 show the internal structure of the pristine sample. The surface was slightly polished with fine-grit sandpaper after cutting. Boxes outline areas of interest that were subsequently focused on.

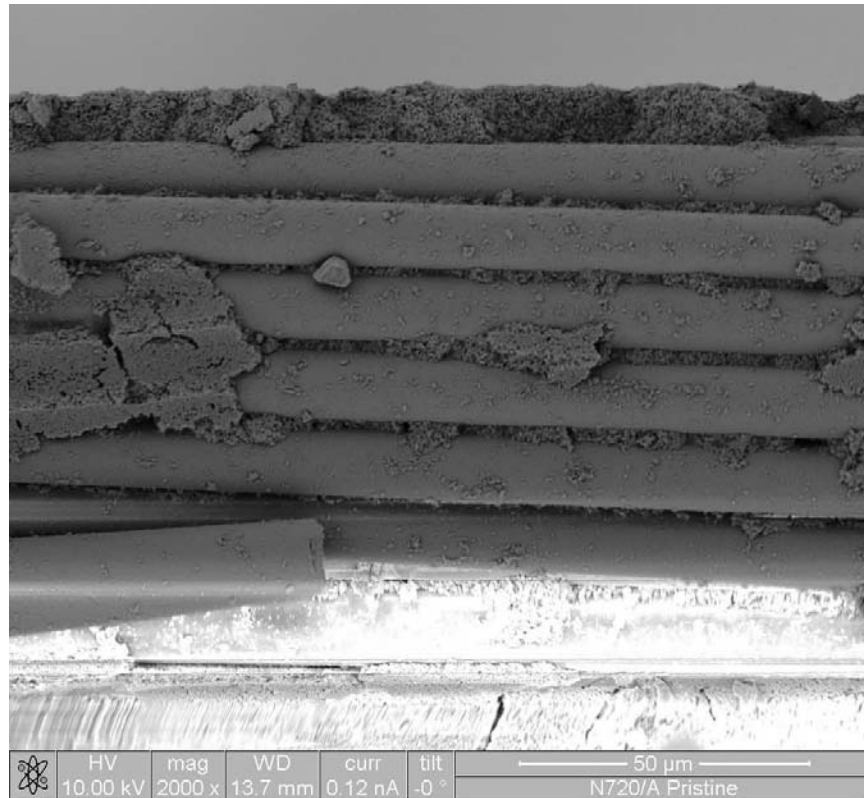
Figure 56. Flame Side 0° Fiber Bundle (Flame Side Edge at Top)

interface due to the combustion environment. A comparison of the fiber-matrix interface on 0° fibers bundles at the edges of the specimen was performed. Figure 56 and Figure 57 show these fiber bundles at the fracture surface edges.

The matrix porosity and interface between the fibers looks similar on both the flame side and rear fracture surfaces of the specimen. This shows that the specimen fracture on the edges in the 0° fiber direction was similar, and the combustion environment did not affect the interface. Figure 58 to Figure 65 show the front fracture surface details.

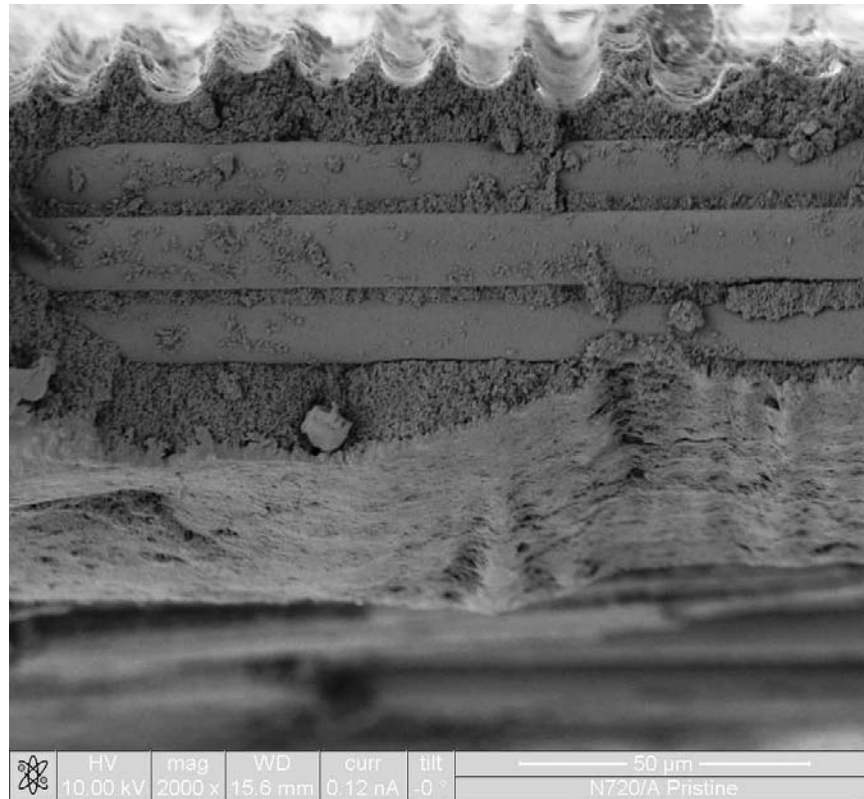
Figure 57. Rear Side 0° Fiber Bundle (Rear Edge at Bottom)
